Bright is the New Black – Multi-Year Performance of Generic High-Albedo Roofs in an Urban Climate

Abstract. High-albedo white and cool roofing membranes are recognized as a fundamental strategy that dense urban areas can deploy on a large scale, at low cost, to mitigate the urban heat island effect. We are monitoring three generic white membranes within New York City that represent a cross-section of the dominant white membrane options for U.S. flat roofs: (1) an ethylene propylene diene monomer (EPDM) rubber membrane; (2) a thermoplastic polyolefin (TPO) membrane and; (3) an asphaltic multi-ply built-up membrane coated with white elastomeric acrylic paint. The paint product is being used by New York City's government for the first major urban albedo enhancement program in its history. We report on the temperature and related albedo performance of these three membranes at three different sites over a multi-year period. The results indicate that the professionally installed white membranes are maintaining their temperature control effectively and are meeting the Energy Star Cool Roofing performance standards requiring a three-year aged albedo above 0.50. The EPDM membrane however s

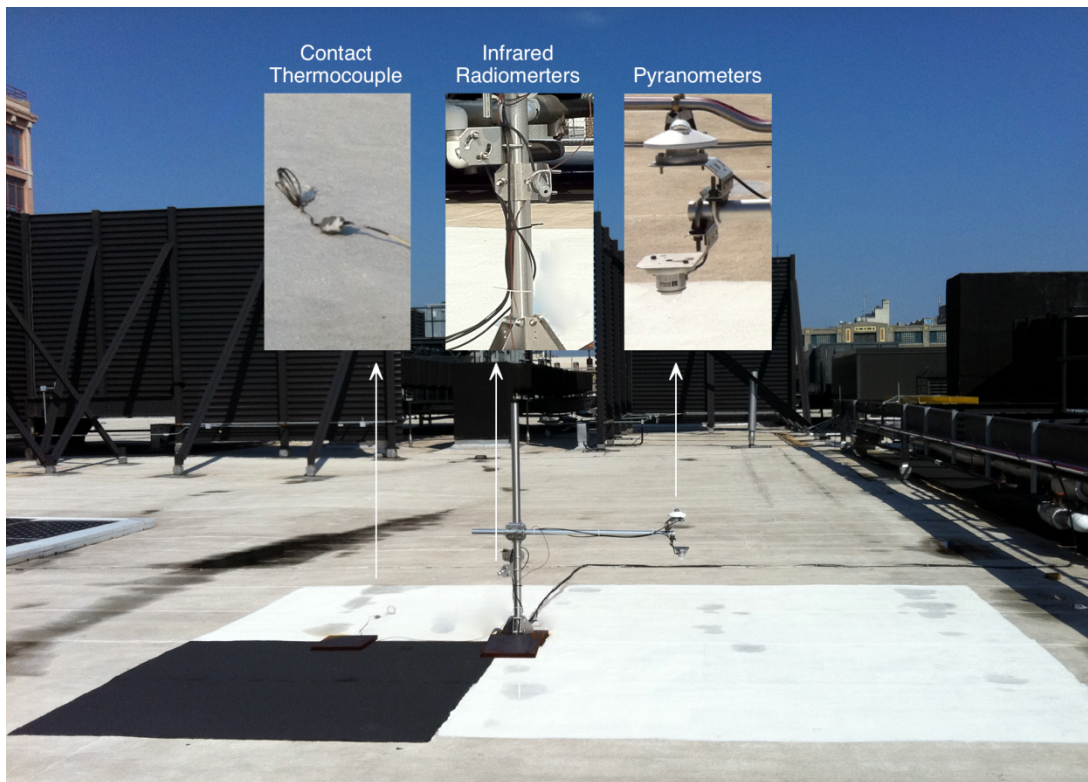
Figure 1. White elastomeric acrylic paint surface, black asphaltic control membrane and instrumentation at the MoMA Queens test site (Long Island City, New York, NY). The surrounding grey area is the aged white roof that had darkened significantly in the two-years before the sensor deployment began.

The pyranometer boom arm was lowered to approximately 45 cm above the surface (figure 1) to minimize, and ideally eliminate, far field non-test surface light contamination. We acknowledge the possibility that not all far field contamination was eliminated.

We installed a contact thermistor to the white surface in addition to the infrared (IR) radiometric temperature sensor (shown in figure 1) in order to provide an estimation of the emissivity, as an alternative method to using an emissometer, which was not available for this project. The infrared sensor is programmed with an assumed emissivity of 0.95, which is appropriate for many organic-based materials and many other natural surfaces. If there is a difference between the contact temperature, which measures true temperature, and the IR sensor reading, it means there is an emissivity difference from the assumed value of 0.95. The actual emissivity can then be determined using the following formula:

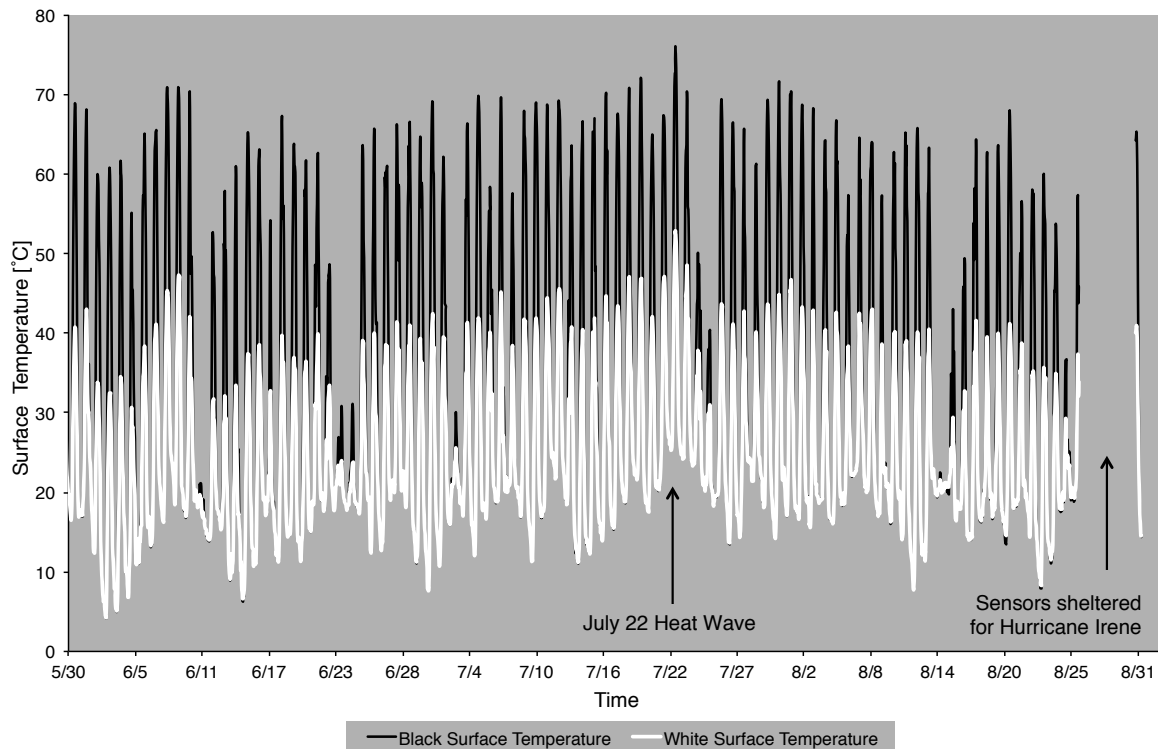
Figure 2. Comparative white and black roof temperatures at the MoMA Queens site, where white acrylic paint was applied to a black asphaltic substrate. Data are shown for the meteorological summer June-August 2011.

During the summer, peak black membrane temperatures often reach 70°C (158°F) (figure 2). During a record-breaking heat wave on July 22, 2011 the peak black rooftop temperature exceeded 76.5°C (170°F). Electric power load was the highest in the City's history at 13,189 MW [22]. Clearly under such conditions a preponderance of black urban rooftops is contraindicated as it is contributing a significant heat burden onto the city's atmosphere, buildings and energy demand.

Daytime peak black temperatures were on average 24°C (75°F) warmer than the test white surface. The temperature difference is most strongly a function of sunlight as seen by looking at cloudier days, with cooler temperatures, when the temperature differences decrease markedly.

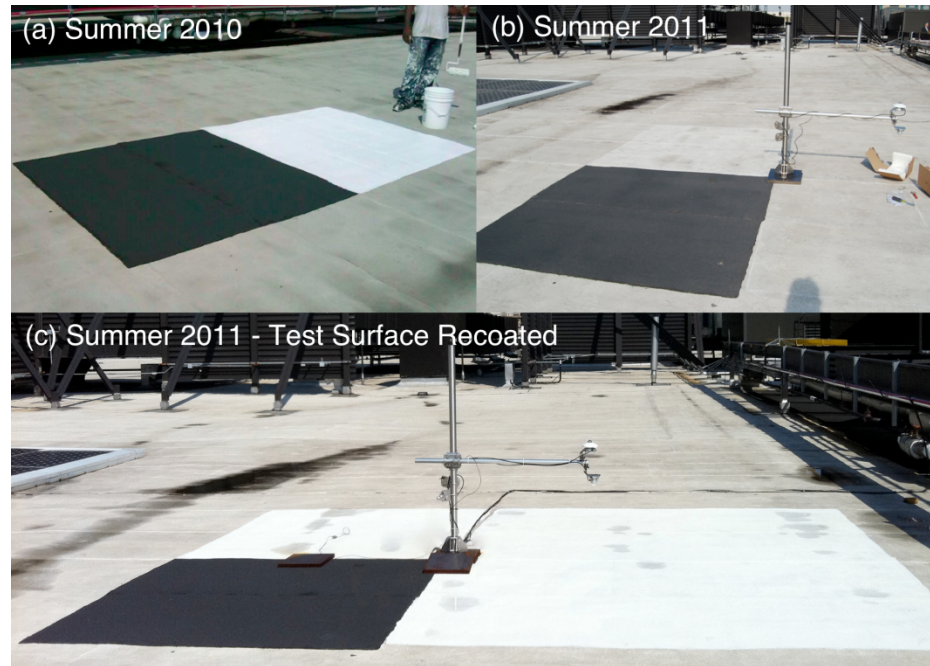
Figure 3. White roof conditions during the summers of 2010 and 2011 showing albedo loss effects over time. The original black membrane was first coated in Summer 2009. (a) Surface conditions one year later after a fresh test patch was applied in Summer 2010. (b) Surface conditions two years later just before sensor deployment began. (c) Surface conditions at the start of data collection after a second recoating.

Although this project is recent, the roof was originally treated with the paint coatings two years prior to the data collection in the present study (sequential photos in figure 3).

Inspection of the surface (figures 3(b) and 3(c)) shows that rainwater ponding is a significant contributor to darkening. Also runoff from rooftop infrastructure (figure 3(c)) appears to lead to darkening. In addition, it may be that the technical approach itself – applying white paint coating on top of a black asphaltic surface – is at a disadvantage because over time, with large temperature cycling, the granulated asphalt surface may be beginning to become partially exposed itself or may be emitting oils that surface [23]. It was noted above that the building is located adjacent to a busy urban thoroughfare. Such transportation arteries may be creating a local air pollution or soot load that could be contributing to the rooftop darkening as well. Sorting out which of these factors is dominant, if any, will require further research such as locating possible air pollution readings for the area. Our impression from multiple visits, however, leads us to believe the granular dark substrate is a primary factor. On the other hand, Cheng *et al* [25] compared solar reflectance declines between urban and rural test sites and found larger declines in the urban setting leading them to conclude air particulates was the dominant effect.

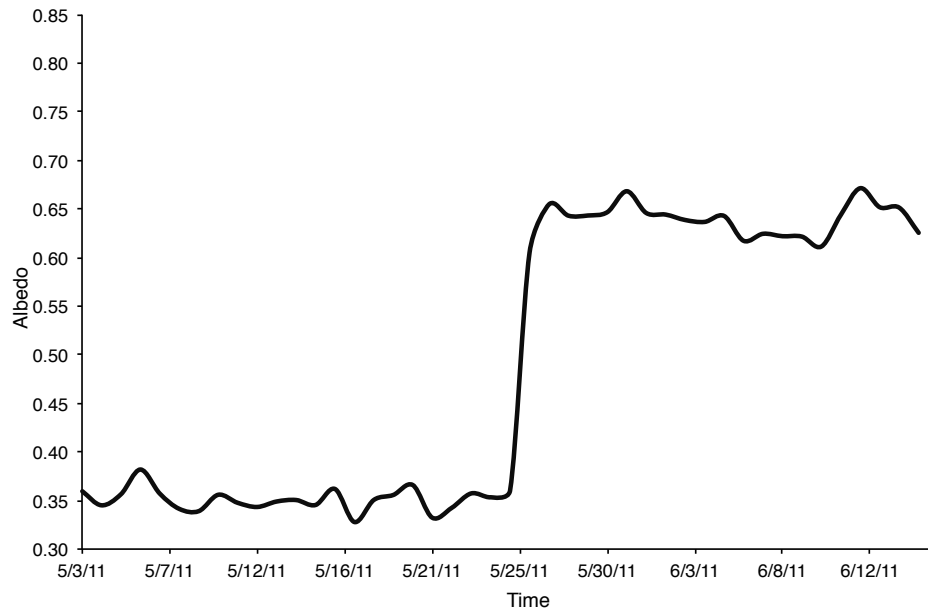
Figure 4. Observed albedo data for the MoMA Queens site before (at 2 years of age) and after a fresh acrylic paint recoating, which took place on May 25, 2011.

Albedo data for the site before and after a fresh recoating, which took place on May 25, 2011, displays a pronounced step function (figure 4). The data clearly shows that after two years, the surface had experienced roughly a 0.30 albedo decline from a presumed initial albedo of 0.65, representing almost a 50% albedo loss in two years. The field-measured fresh albedo is also lower than the rated performance for fresh solar reflectance from the product manufacturer of 0.87 – an example of the possible inaccuracy of the solar reflectance methods as a proxy for field albedo.

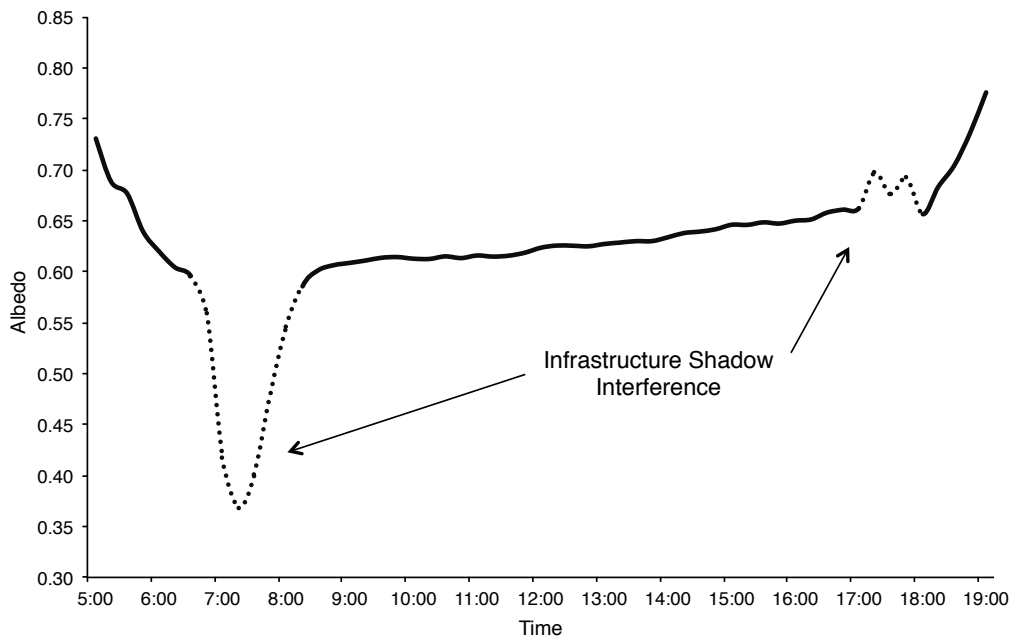
Figure 5. Hourly averaged albedo data for the MoMA Queens site during the summer of 2011 showing the change during the daily solar cycle. Dashed lines indicate interference by rooftop infrastructure, which cast shadows on the sensors during sunrise and sunset.

Hourly averaged albedo gives an indication of the change in albedo during the daily solar cycle (figure 5). In a dense urban setting like New York City, early morning and late evening shadowing is almost

unavoidable as the ubiquitous building and infrastructure on the horizons will impact the incident light during sunrise and sunset. Such shadowing can result in a lowering of albedo if the shadow falls on the test membrane, or an elevation of albedo if it falls on the skyward sensor. These interference effects arose with the current deployment and are noted by dashed line in Figure 5. As is well-known (e.g., [26, 27]) albedo is generally a strong function of solar incidence angle, and is usually higher during early morning and late evening hours at high incidence angles [28]. Ignoring the shadowing effect, albedo on the membrane surface shows a characteristic U-shaped profile (figure 5).

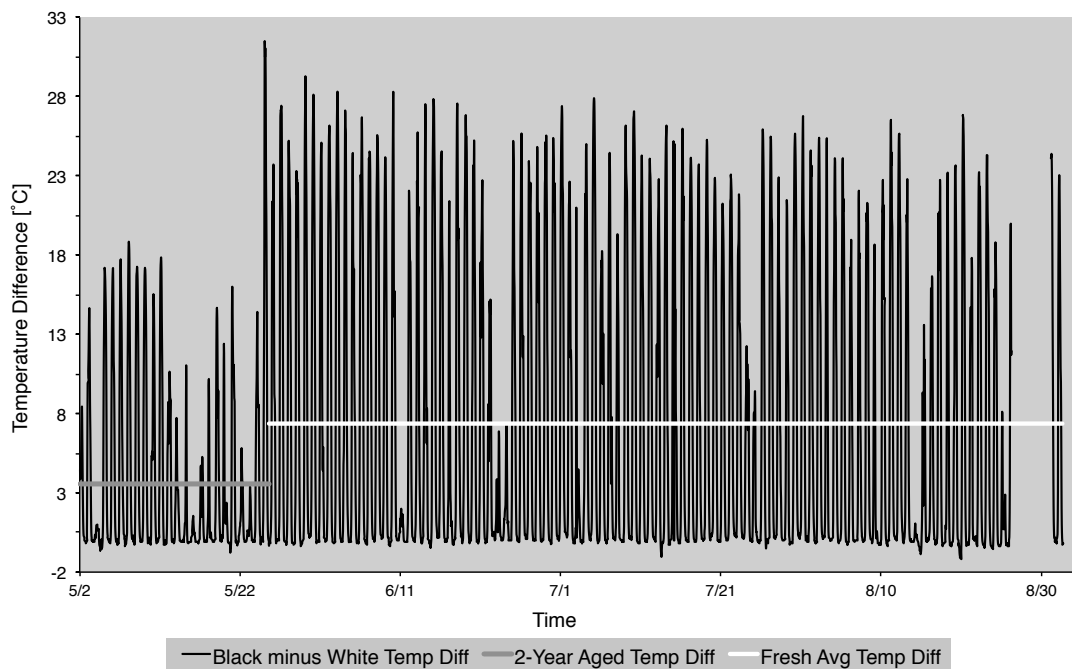
Figure 6a. Hourly black minus white temperature differences measured over summer 2011 at the MoMA Queens site. Also shown are the average pre-recoating difference value (horizontal grey line) and post-recoating difference value (horizontal white line).

The albedo losses over time do have a significant impact on temperature. Temperature difference plots between the black and white surfaces (figures 6a and 6b) show that the aged white surface does warm considerably relative to black. The hourly average difference plots for the fresh and aged surfaces (figure 6b) show that after two years the white surface has lost roughly half of its cooling performance, consistent with its 50% decline in albedo.

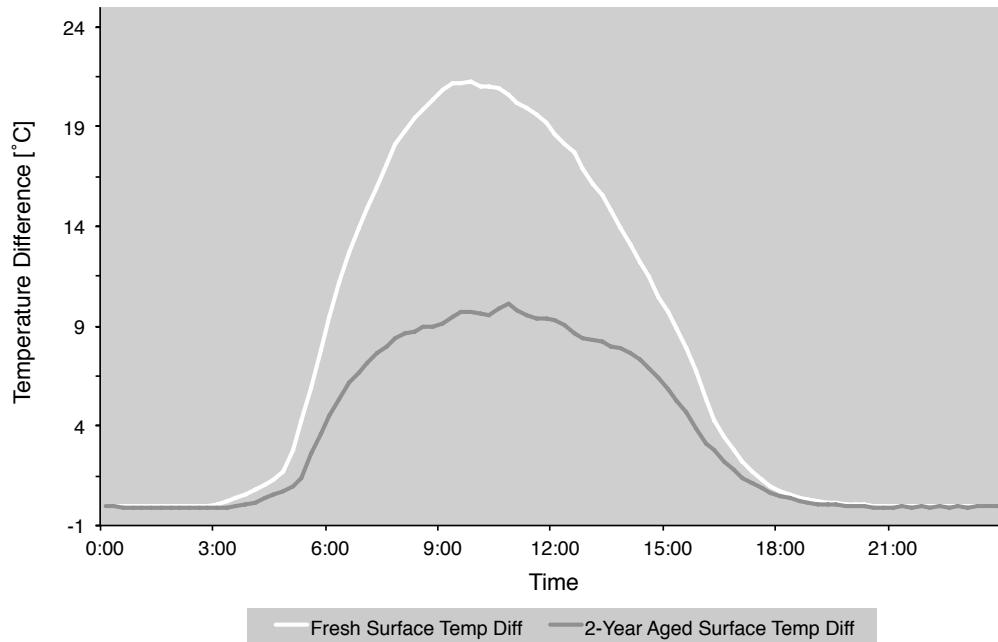
Figure 6b. Black minus white surface temperature differences averaged over the diurnal cycle for the fresh coating (white line) and also for the 2-year aged surface (grey line) at the MoMA Queens site. The aged surface lost approximately half its temperature control, consistent with an approximately 50% albedo loss.

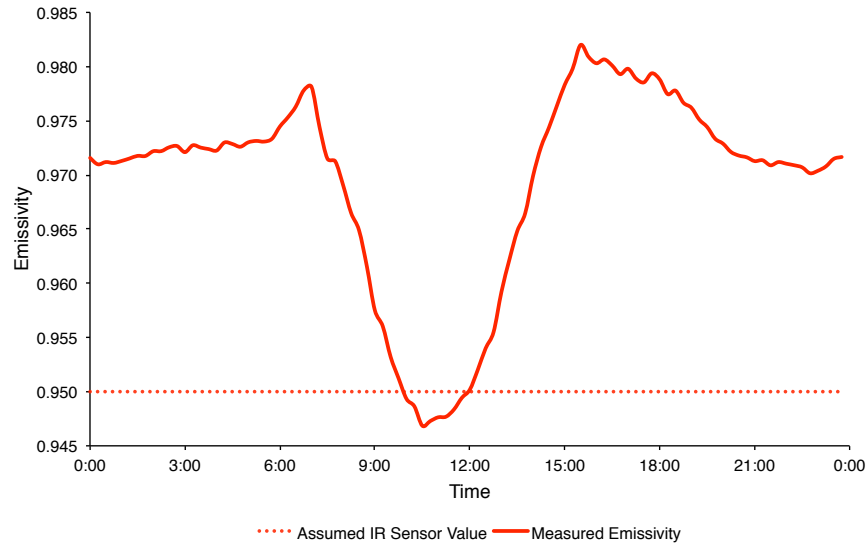
Figure 7. Average hourly emissivity values at the MoMA Queens site, calculated using data for equation (1), over the diurnal cycle are shown by the upper fluctuating line. The constant dashed line is the assumed infrared sensor emissivity of 0.95 that was programmed into the datalogger.

The emissivity as calculated using equation (1) (figure 7) is close to the assumed 0.95 value, at around 0.97 and this represents a trivial temperature correction as far as the IR sensor data is concerned. We observe however an interesting diurnal cycle with the emissivity dropping slightly during the daytime and rising at night (figure 7). We are not able to evaluate the exact cause of this cycle but speculate that it could be an effect of dew formation at night where the water at the surface slightly increases the surface emissivity and then evaporates during daytime. It may also be a direct temperature effect on material emissivity. The literature on time-varying emissivities is not extensive as such data may be difficult to obtain in field experiments.

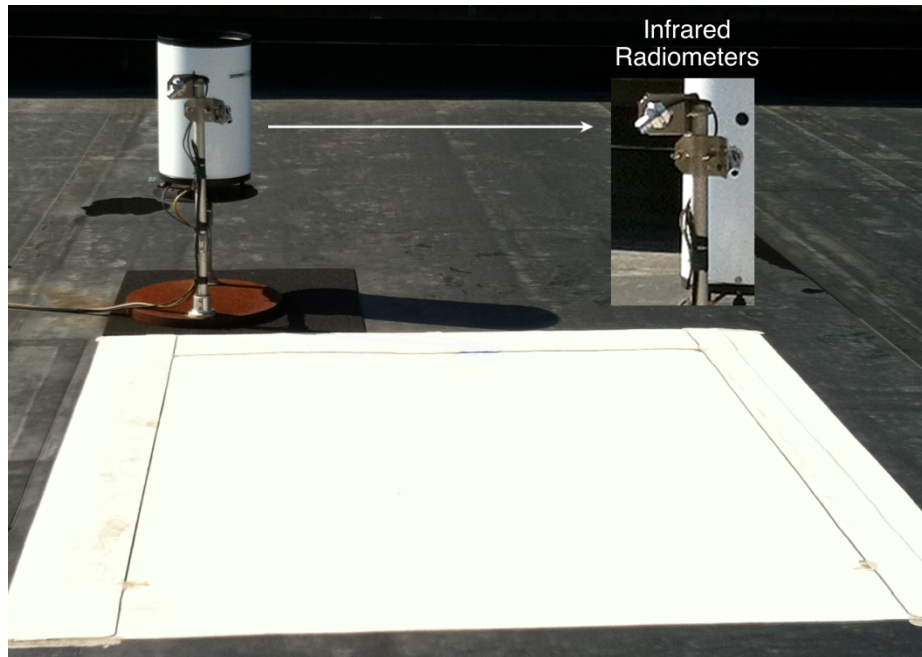
Figure 8. Black and white EPDM membranes and surface IR temperature sensors (the white bucket in the background is a rain gauge) at the Con Edison study site. The membranes are three years old at the time of this photograph and the white membrane has not been cleaned during that time.

Monitoring at this site began in October 2008. Only infrared surface temperatures are being measured at this site (figure 8), not albedo or emissivity, because of project budget constraints. The white and black membranes are approximately three years of age at the time of the photograph (figure 8) and have not been cleaned during that time. Some data communication problems led to lost temperature data for portions of the monitoring period as seen in the figure 9.

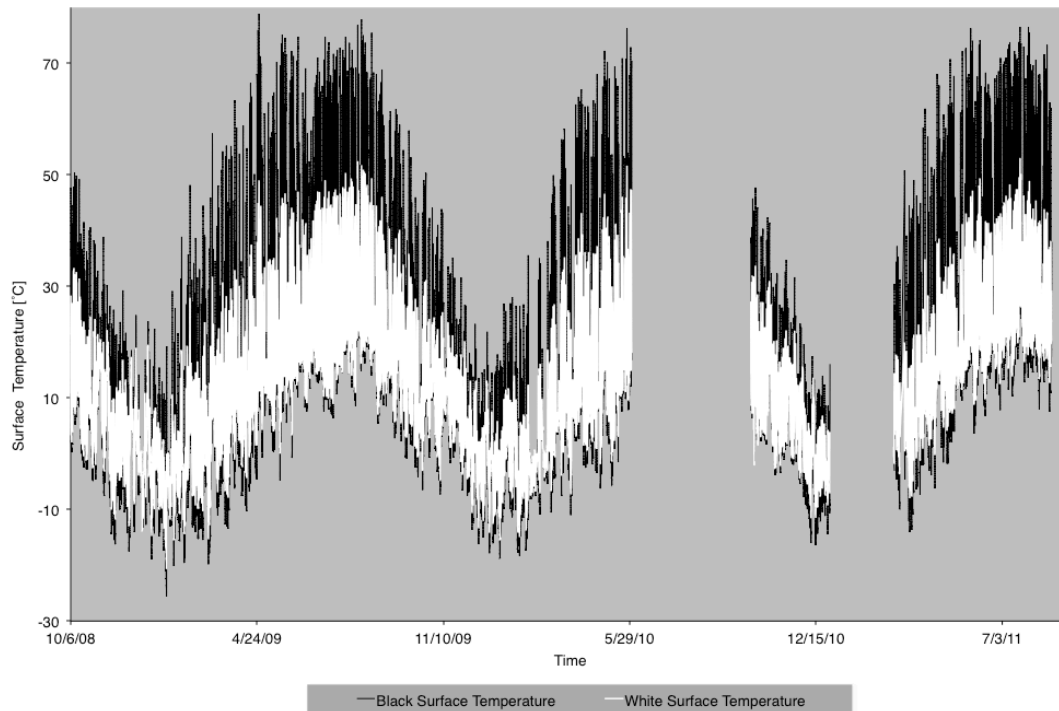
Figure 9. Nearly three years of average hourly black and white membrane temperatures observed for the black and white EPDM single-ply membranes at the Con Edison site (October 2008 – August 2011).

The dramatic warm season temperature differences are evident at the Con Edison site. The black membrane temperature cycles are vastly greater and, as noted with the MoMA site, will create greater material thermal stresses and degradation over time. Indeed during the summer, black membrane temperature cycles have an amplitude approaching 70°C (126°F) in a single day.

The multi-year data (figure 9) do not suggest a significant loss in temperature control by the white EPDM membrane relative to black over the 3-year period. Indeed comparing Tables 1 and 2, for meteorological Summer 2011, the EPDM membrane and acrylic paint membrane show very similar temperatures. As the specification sheet for the EPDM indicated a 3-year aged albedo of 0.64 and figure 4 indicates the acrylic surface also had an albedo of approximately 0.64, our data are consistent with a 3-year aged EPDM albedo in the range of 0.64. Thus the aged EPDM membrane is performing as well as the new acrylic membrane.

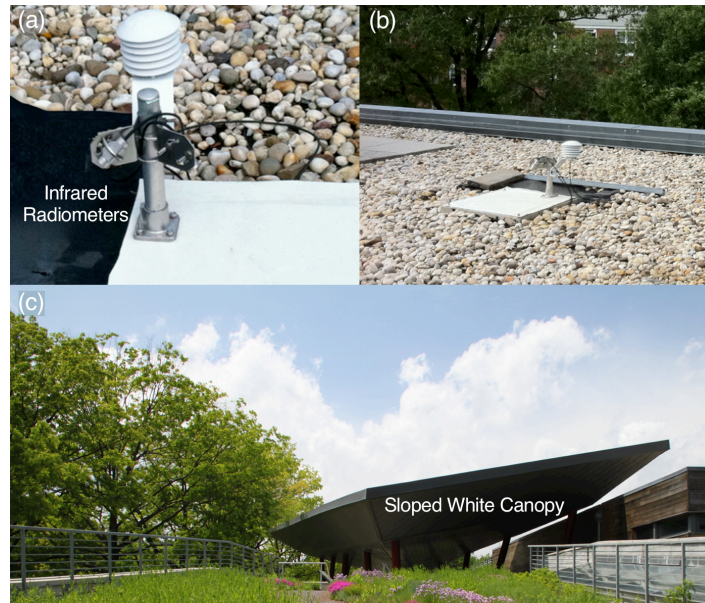
Figure 10. Sensor and test surfaces set up on the Queens Botanical Garden.

The membrane was installed on a sloping canopy intended for stormwater runoff control (seen in figure 10(c)) and was thus not suitable for a horizontal temperature analysis. Therefore, we installed a test sample of the membrane horizontally next to an exposed black geotextile cloth (Figure 10(a)). The experimental arrangement is thus not ideal but the best available substitute to acquire performance data at this site. Due to project budget constraints, only black and white IR surface temperatures are being monitored here.

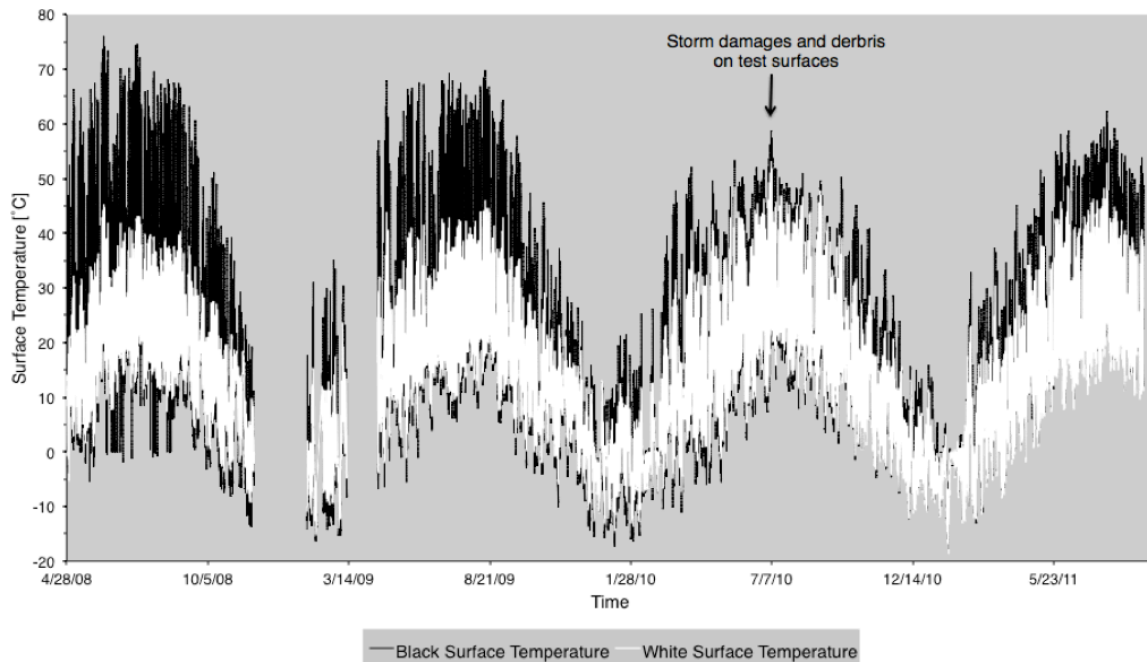
Figure 11. Hourly black and white membrane temperatures at the Queens Botanical Garden site (2008-2011). The test site roof experienced severe storm weather damage during the Summer 2010.

We found that the difference in temperature between the two surfaces decreases over time. This is mainly due to black membrane cooling especially during Summer 2010. That season was a particularly stormy one for the location. There were high winds early in the season that overturned the rain gauge and damaged the roof and spread debris widely, including over the membranes. Later in the season, a highly-anomalous tornado touched down nearby and inflicted severe damage to trees in the area. These events and debris likely affected the temperature readings during Summer 2010. The black surface dust and debris may have lightened its color over time, leading to the observed cooling over the years. Judging just the white TPO membrane cycles however, it appears that the white temperature performance has been relatively stable over the three years and that the albedo has not declined markedly.
